"Full" Reserve Study

Cypress Island HOA Wilmington, NC

Report #: 18685-0
For Period Beginning: January 1, 2019
Expires: December 31, 2019

Date Prepared: December 5, 2018

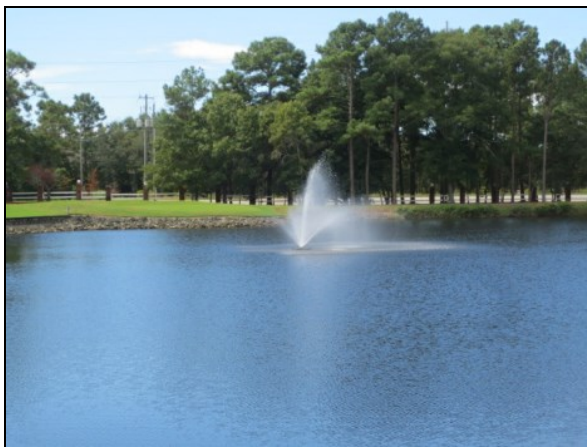
Comments: Under normal circumstances, well-maintained retention ponds should not require major repair/refurbishing projects. In some cases, large projects such as erosion control, weed abatement or dredging may be required, but the scope and frequency of such projects is very unpredictable. As a precaution, the association may want to budget an "allowance" for repairs to the ponds which can be found below. The association should consult with pond service vendor on a regular basis to identify any necessary projects, which may be included within future Reserve Study updates as needed.

Useful Life:
20 yearsRemaining Life:
10 years

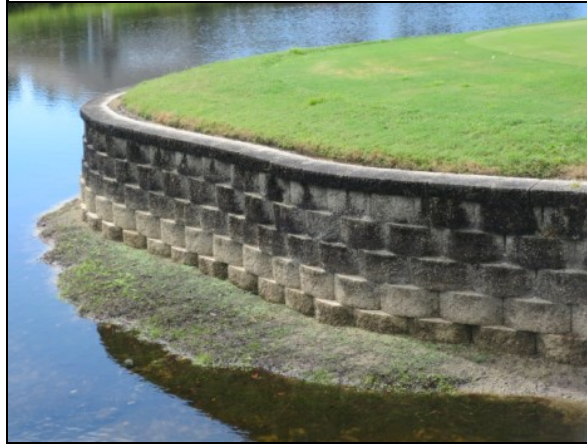
Comments: Concrete bulkheads determined to be in fair condition may exhibit more noteworthy deterioration on exposed surfaces. May show some sections of erosion or sinking at land side behind wall. Few or no reports of any serious concerns at this stage. Under normal circumstances, properly designed and constructed bulkheads could have a very long useful life, sometimes with no predictable need for complete replacement. Repairs are often required as a development ages, but the nature of the repairs, including scope and frequency can vary greatly based on many factors. Comprehensive inspection of all wall components, including sub-surface elements is not included within the scope of this engagement. We recommend periodic professional inspections by a qualified engineer, marine contractor or other professional to identify any urgent problems. If a more specific scope of work can be identified, we recommend updating the Reserve Study to incorporate appropriate funding recommendations as needed. Based on our experience with other comparable properties, we recommend budgeting an ongoing allowance for repairs, or in advanced stages of failure, comprehensive replacement.

Useful Life:
40 yearsRemaining Life:
18 years

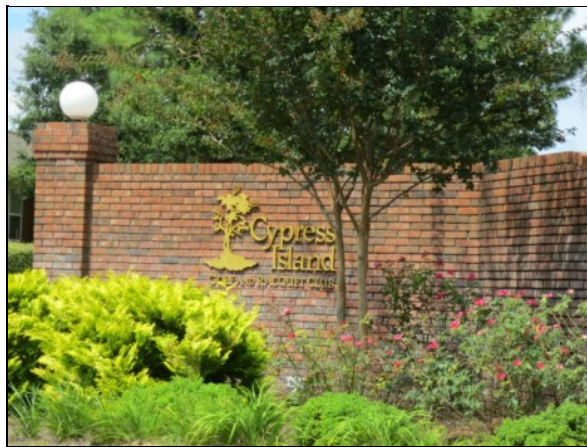
Comments: Routine daily/weekly/monthly maintenance is expected to be funded through the Operating budget. However, this component represents a supplemental "allowance" for larger projects which may occur periodically, such as renovation/restoration of landscaped areas, new trees, hedges, flower beds, etc. Timing and costs of such projects are very subjective. Estimates shown here should be re-evaluated by the Association over time and adjusted as needed during future Reserve Study updates.

Useful Life:
20 yearsRemaining Life:
10 years
