Cypress Island HOA
Wilmington, NC

Report #: 18685-1
Beginning: January 1, 2022
Expires: December 31, 2022

RESERVE STUDY
Update "With-Site-Visit"

December 23, 2022

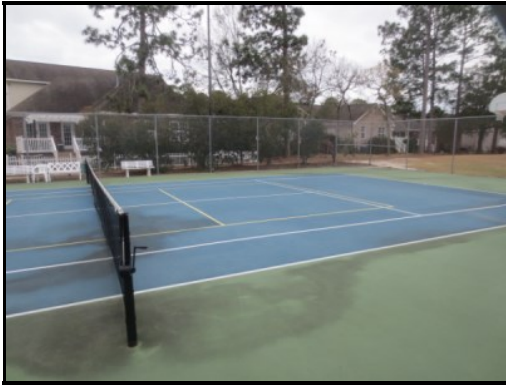
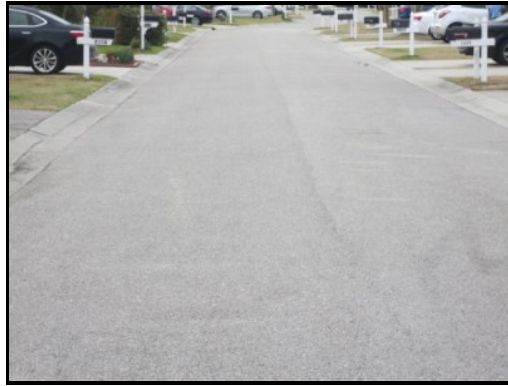
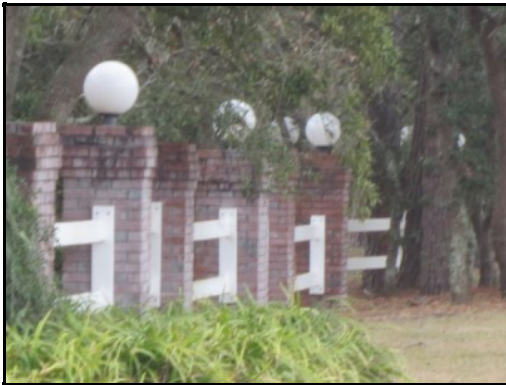
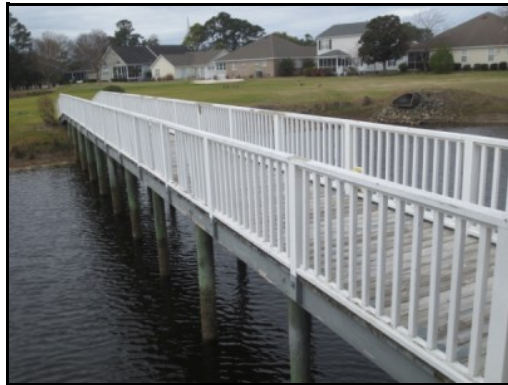
Site Inspection Notes

Since our last visit to the community, there have been some changes. The longest bridge will be torn down soon due to safety concerns. Also, there are numerous golf course rehab project that are expected to occur. The asphalt roads are weathered and deterioration and a full resurfacing project is expected to occur in the next 5 years.

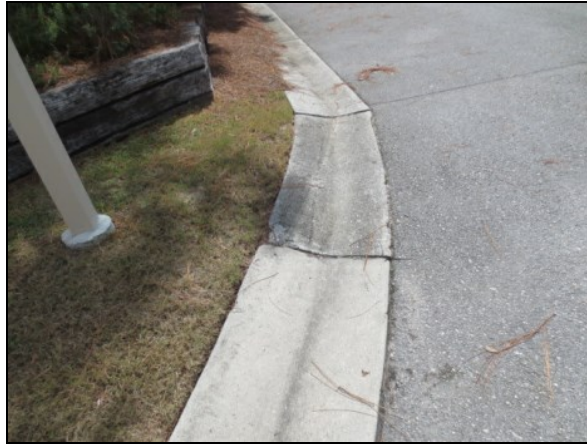
History: Repairs were noticed

Lower allowance to replace

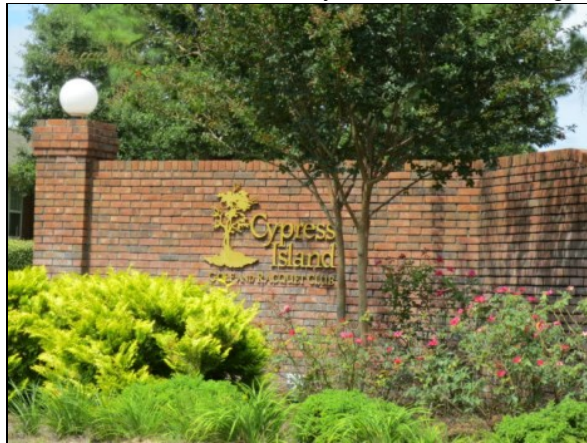
Comments: Routine daily/weekly/monthly maintenance is expected to be funded through the Operating budget. However, this component represents a supplemental "allowance" for larger projects which may occur periodically, such as renovation/restoration of landscaped areas, new trees, hedges, flower beds, etc. Timing and costs of such projects are very subjective. Estimates shown here should be re-evaluated by the Association over time and adjusted as needed during future Reserve Study updates.

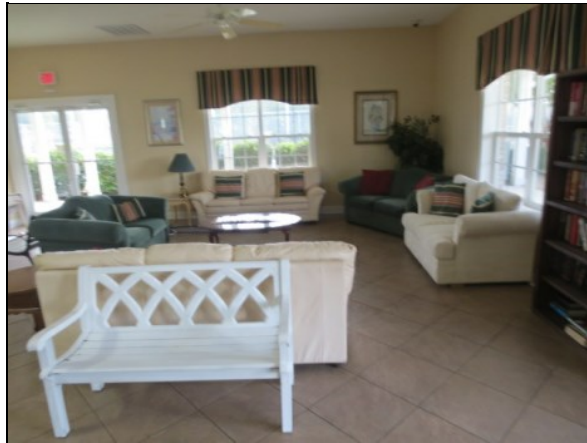
Comments: (5) couches, (7) tables, (4) benches, (14) chairs, (4) rocking chairs, (1) TV and 19 LF of cabinets. counted during inspection. We recommend regular inspections and repair or replacement of any damaged pieces promptly to ensure safety. Protected storage of furniture when not in use can help to extend useful life. Best practice is to replace all pieces together in order to maintain consistent style and quality in the pool/recreation area. Costs can vary greatly based on type of pieces selected for replacement. Funding recommendation shown here is based on replacement with comparable number and quality of pieces.
