"Full" Reserve Study

Cypress Island HOA Wilmington, NC

Report #: 18685-0
For Period Beginning: January 1, 2019
Expires: December 31, 2019

Date Prepared: December 5, 2018

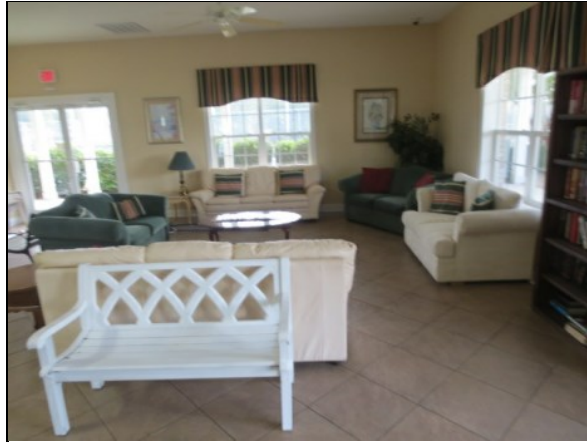
Comp #: 2743 Furnishings/Decor - Partial Replace**Quantity: (35) Furnishings**

Comments: (5) couches, (7) tables, (4) benches, (14) chairs, (4) rocking chairs, (1) TV and 19 LF of cabinets. counted during inspection. We recommend regular inspections and repair or replacement of any damaged pieces promptly to ensure safety. Protected storage of furniture when not in use can help to extend useful life. Best practice is to replace all pieces together in order to maintain consistent style and quality in the pool/recreation area. Costs can vary greatly based on type of pieces selected for replacement. Funding recommendation shown here is based on replacement with comparable number and quality of pieces.

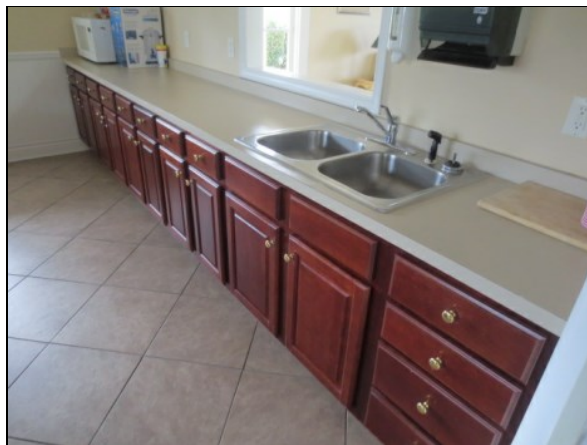
Comments: Kitchen is in fair condition overall. Kitchen materials typically have an extended useful life. However, many Associations choose to refurbish the kitchen periodically for aesthetic updating. This may include refurbishment/refinishing of kitchen cabinets and countertops, replacement of sinks, installation/replacement of under-cabinet lighting, etc. Should ideally be coordinated with replacement of the kitchen appliances. Best practice is to coordinate this project with other amenity areas, such as bathrooms or other amenity rooms.

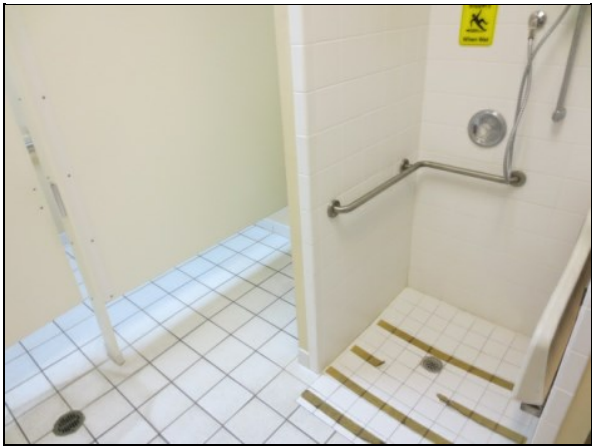
Comments: Bathrooms determined to be in fair condition typically exhibit some light to moderate signs of use and age. Finishes are clean but showing some wear. All fixtures are assumed to be functional, but may be becoming outdated at this stage. As routine maintenance, inspect regularly and perform any needed repairs promptly utilizing general Operating funds. Typical remodeling project can include some or all of the following: replacement of plumbing fixtures, partitions, countertops, lighting, flooring, ventilation fans, accessories, décor, etc. Costs can vary greatly depending on scope of work involved. Unless otherwise noted, estimates shown are based primarily on light to moderate cosmetic remodeling, not complete "gut" remodel projects.

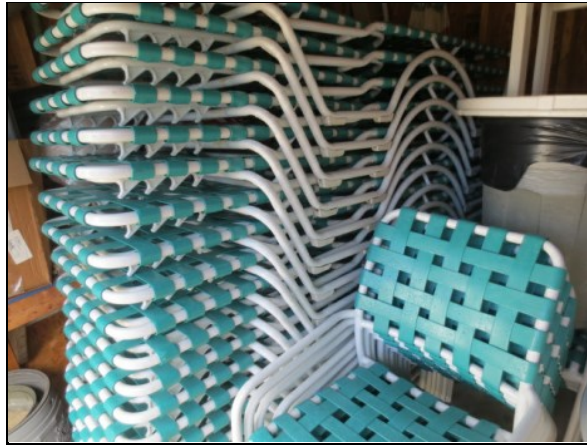
Comp #: 2763 Pool Deck Furniture - Replace

Comments: Some surface wear noticed but furniture was stored and could not be fully inspected. (20) lounge chairs, (5) tables, (20) chairs and (5) umbrellas counted during inspection. Pool deck furniture determined to be in fair condition typically exhibits routine, noticeable signs of wear and age, but appearance is still decent and consistent, acceptable for the standards of the property. Some pieces, especially lounge chairs, tend to show more signs of age at this stage.

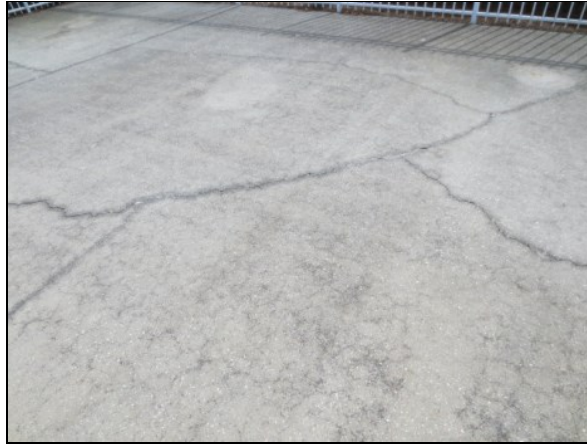
Comp #: 2769 Pool Deck - Partial Replace

Comments: Concrete pool decks should have a long useful life under normal circumstances. Some cracks and repairs noticed during our inspection. Should be pressure-washed as needed to preserve appearance and remove stains, chemical residue, etc. Replacement costs can vary depending on style of concrete chosen, configuration of deck, etc. We recommend budgeting for replacement at the approximate interval shown here.

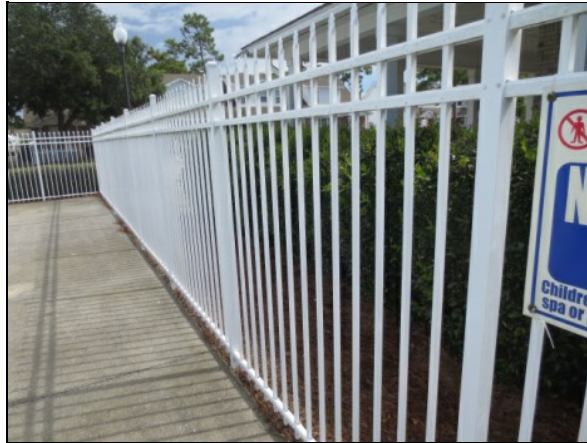
Comp #: 2771 Pool Fence - Replace**Quantity: Approx 255 LF**

Comments: White alluminum fence. Pool fencing determined to be in fair condition typically exhibits some minor amounts of surface wear and other signs of age, which may include corrosion, loose or unstable pieces/sections or hardware, and/or overgrowth by surrounding vegetation. Overall, appears to be in serviceable but declining condition. As a routine maintenance item, fence should be inspected regularly and repaired as-needed to ensure safety. Periodically clean with an appropriate cleaner and touch up paint as needed in between regular paint cycles. When evaluating replacements, be sure to comply with any applicable building codes. Gates and locks should be inspected to make sure they close and lock properly. Faulty perimeter around a pool area can expose an Association to significant liability risk. When possible, replacement should be coordinated with other projects, such as pool deck projects, other fencing/railing work, etc.

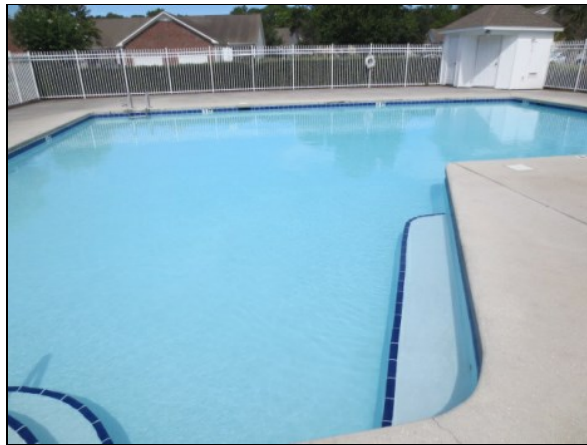
Comments: Approximately 1,444 GSF footprint area with 164 waterline/perimeter length. Depth ranges from 3' to 5'. Swimming pools determined to be in fair condition typically exhibit some color fade/discoloration, and roughening of the surface, often more noticeable in the shallow areas and/or at steps. Waterline tiles are in fair condition. Generally believed to be aging normally.

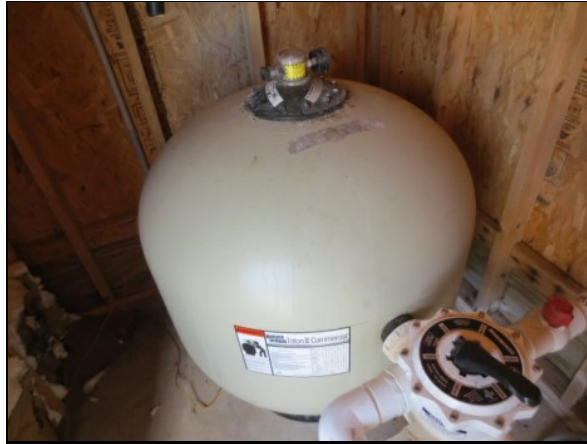
Comp #: 2779 Pool Filter - Replace**Quantity: (2) Filters**

Comments: (2) Triton TR140C (2008). Pool vendor should inspect regularly for optimal performance and address any repairs or preventive maintenance as needed. Life can vary depending on location, as well as level of use and preventive maintenance. Plan to replace at the approximate interval shown below.

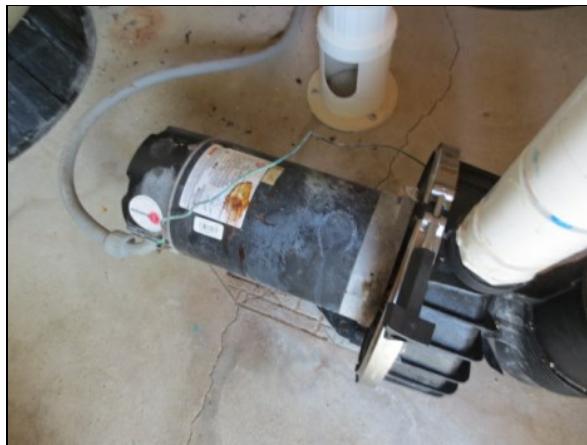
Comp #: 2783 Pool Pumps - Replace**Quantity: (1) Pump, 3 HP**

Comments: Pumps should be inspected regularly for leaks and other mechanical problems. Cost shown is based on replacement with the same type and size unless otherwise noted, and includes small allowance for new piping/valves/other repairs as needed.

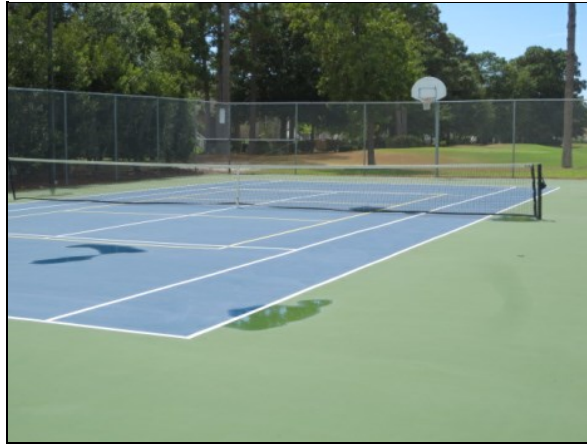
Comments: Tennis courts determined to be in good condition typically exhibit smooth and consistent texture and good coloring with high contrast of playing lines. Drainage appears to be adequate and overall appearance is good. Inspect courts regularly and locally repair as needed within the annual Operating budget. Cracks and trip hazards should be addressed promptly to ensure safety. Re-coating is a recommended practice for restoring appearance of the court, bridging small surface cracks, and prolonging the life of the court surface itself. Plan to re-coat (includes striping) at the approximate interval shown below. Maintenance projects such as pressure-washing should be considered as Operating expense.

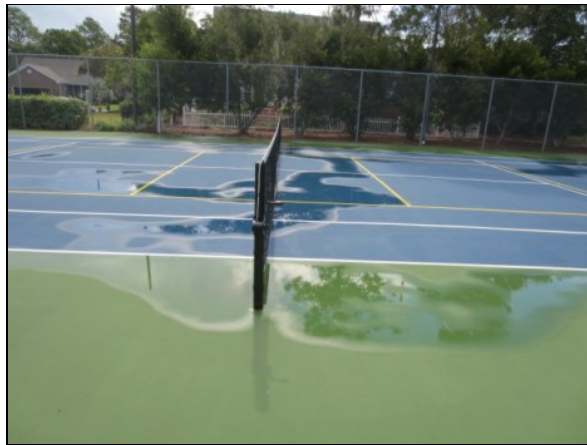
Comments: Assuming proper maintenance and proper re-coating schedules, the court surface should have a relatively long life expectancy. Over time, exposure to UV light, wind rain and foot traffic will deteriorate the surface to the point of failure. Prior to resurfacing, consult with vendors to identify any structural problems, such as poor grade, lack of drainage, high spots, etc. Plan to resurface at the approximate interval shown below in order to preserve the appearance and usefulness of the court surface. Best practice is to coordinate with other projects, such as fencing and/or lighting replacement.
