Cypress Island HOA
Wilmington, NC

Report #: 18685-1
Beginning: January 1, 2022
Expires: December 31, 2022

RESERVE STUDY
Update "With-Site-Visit"

December 23, 2022

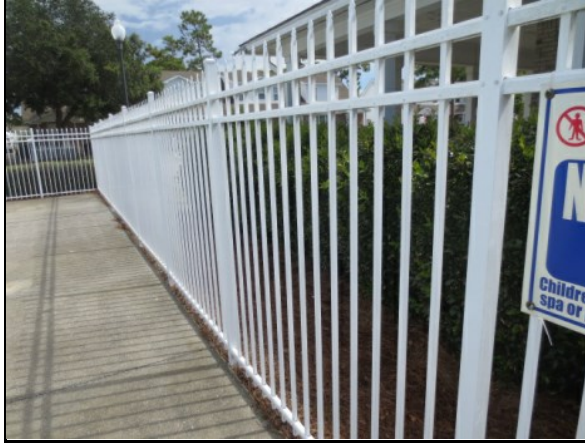
Comp #: 2771 Pool Fence - Replace**Quantity: Approx 255 LF**

Comments: White alluminum fence. Pool fencing determined to be in fair condition typically exhibits some minor amounts of surface wear and other signs of age, which may include corrosion, loose or unstable pieces/sections or hardware, and/or overgrowth by surrounding vegetation. Overall, appears to be in serviceable but declining condition. As a routine maintenance item, fence should be inspected regularly and repaired as-needed to ensure safety. Periodically clean with an appropriate cleaner and touch up paint as needed in between regular paint cycles. When evaluating replacements, be sure to comply with any applicable building codes. Gates and locks should be inspected to make sure they close and lock properly. Faulty perimeter around a pool area can expose an Association to significant liability risk. When possible, replacement should be coordinated with other projects, such as pool deck projects, other fencing/railing work, etc.

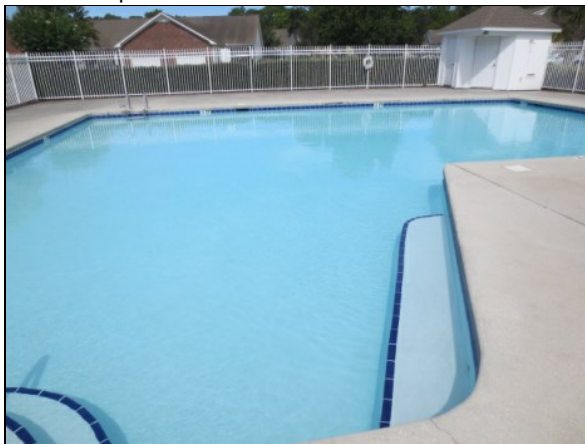
Comments: Approximately 1,444 GSF footprint area with 164 waterline/perimeter length. Depth ranges from 3' to 5'. Swimming pools determined to be in fair condition typically exhibit some color fade/discoloration, and roughening of the surface, often more noticeable in the shallow areas and/or at steps. Waterline tiles are in fair condition. Generally believed to be aging normally.

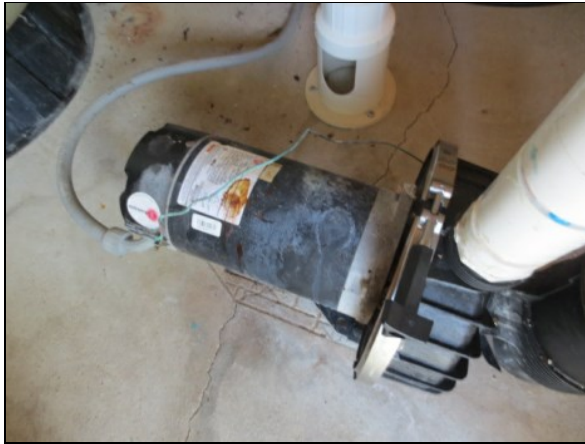
Comp #: 2783 Pool Pump - Replace**Quantity: (1) Pump, 3.5 HP**

Comments: Pumps should be inspected regularly for leaks and other mechanical problems. Cost shown is based on replacement with the same type and size unless otherwise noted, and includes small allowance for new piping/valves/other repairs as needed.

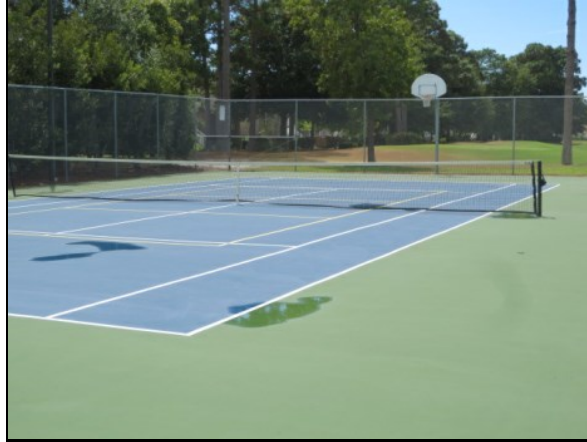
Comments: Tennis courts determined to be in good condition typically exhibit smooth and consistent texture and good coloring with high contrast of playing lines. Drainage appears to be adequate and overall appearance is good. Inspect courts regularly and locally repair as needed within the annual Operating budget. Cracks and trip hazards should be addressed promptly to ensure safety. Re-coating is a recommended practice for restoring appearance of the court, bridging small surface cracks, and prolonging the life of the court surface itself. Plan to re-coat (includes striping) at the approximate interval shown below. Maintenance projects such as pressure-washing should be considered as Operating expense.

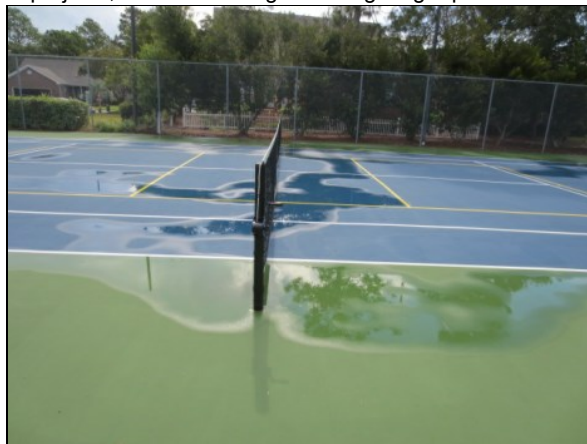
Comments: Assuming proper maintenance and proper re-coating schedules, the court surface should have a relatively long life expectancy. Over time, exposure to UV light, wind rain and foot traffic will deteriorate the surface to the point of failure. Prior to resurfacing, consult with vendors to identify any structural problems, such as poor grade, lack of drainage, high spots, etc. Plan to resurface at the approximate interval shown below in order to preserve the appearance and usefulness of the court surface. Best practice is to coordinate with other projects, such as fencing and/or lighting replacement.

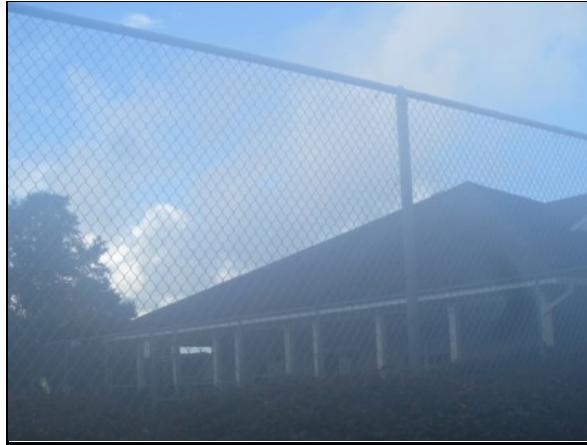
Comp #: 2813 Tennis Court Fencing - Replace**Quantity: Approx 350 LF**

Comments: Tennis court determined to be in fair condition typically exhibits more noticeable surface wear such as cracking or peeling of vinyl coating on chain-link mesh. Posts exhibit some rust and deterioration but overall, fencing is intact, upright and stable. Tennis court fencing should have a very long life expectancy assuming proper design and installation, lack of vandalism/abuse, etc. Best practice is to coordinate replacement with other major projects, such as court resurfacing, lighting replacement, etc. Vinyl-coated chain link fences normally have a longer life expectancy and are more attractive than those without. Gates and locks should be inspected and repaired as needed as an Operating expense in order to restrict access (if desired) to the tennis court. Costs shown here are based on complete replacement of mesh/fabric as well as poles/framework.

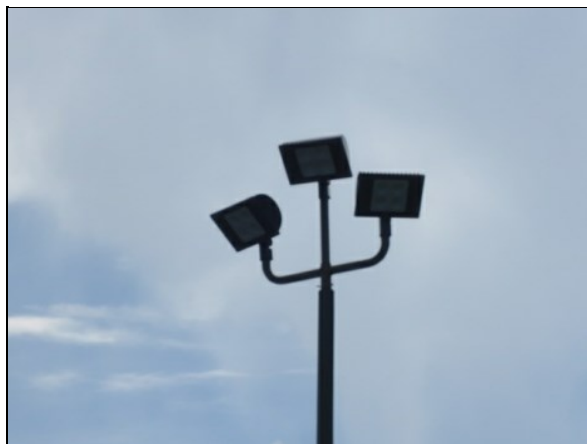
Comp #: 2817 Tennis Court Lighting - Replace**Quantity: (2) Poles, (6) Lights**

Comments: (2) Large 30' poles with (6) LED fixtures. Tennis court lights determined to be in fair condition typically exhibit some weathering and surface wear, but no unusual functional concerns are observed or reported. Generally appear to be aging normally.

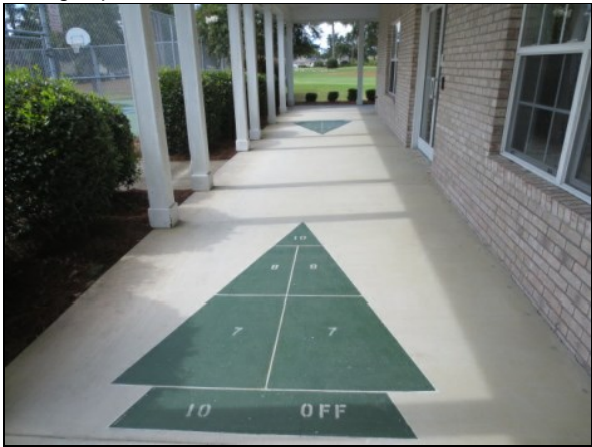
Comp #: 2825 Shuffleboard Court - Repair/Re-coat

Comments: Concrete shuffleboard court in fair condition overall. Determined to be in fair condition typically exhibit some light surface wear and deterioration that may begin to affect play and should be closely monitored. Overall appearance is decent and consistent. Repaint as part of operating expense.

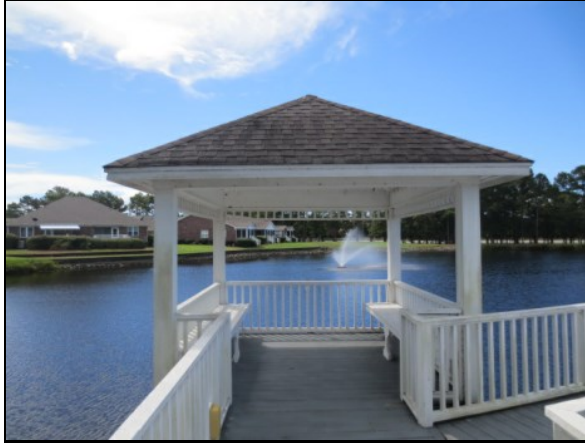
Comments: Gazebo determined to be in fair condition typically exhibit more wear and tear, possibly including some warped, split and/or deteriorated components. Framework/structure should still be sturdy but may have sections showing minor leaning or damage. As routine maintenance, inspect regularly and repair individual pieces or sections as needed from general Operating funds. Clean and paint/stain along with other larger projects or as general maintenance to preserve the appearance of the gazebo and extend its useful life. If present, vegetation should be well-maintained and not allowed to become overgrown, which can eventually compromise the structure. Assuming ordinary care and maintenance, plan for major repairs or possibly complete replacement (if warranted) at roughly the interval indicated below.

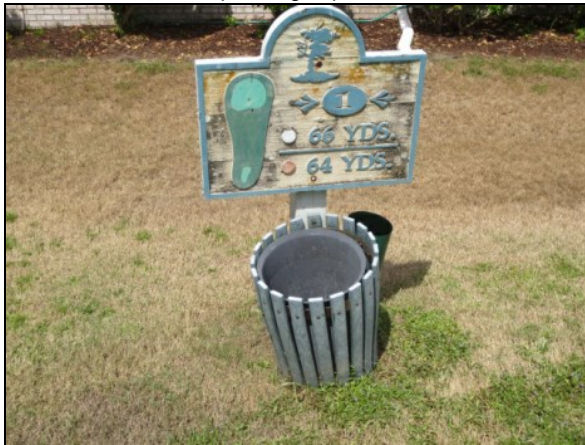
Comp #: 2151 Tee Markers - Replace**Quantity: (9) Signs**

Comments: These can be replaced as needed as an operating expense.

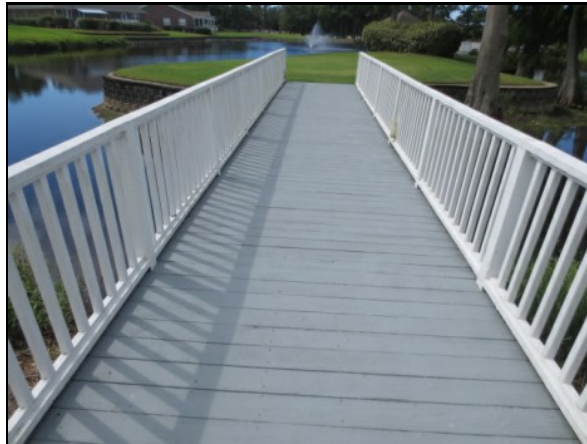
Comments: The largest of the bridges is being removed. It is approx 640 SF. The other two bridges have an estimated replacement cost of \$80,000 Funding recommendation shown here provides for the replacement of wood decking. Should be inspected regularly for safety hazards such as loose or lifting boards, splintering, trip hazards, lifting nails/screws, etc. Useful life can sometimes be prolonged by using sealers or other coatings to protect material from advanced weathering.

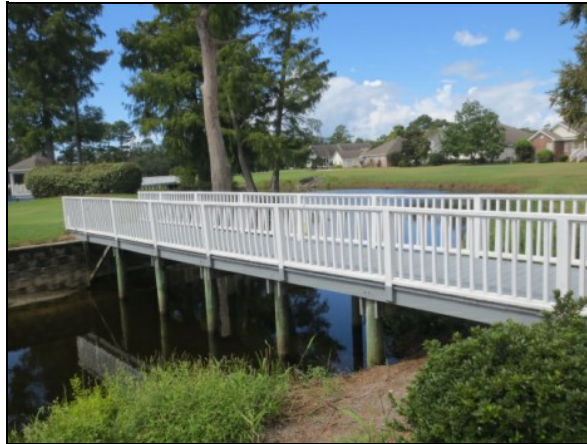
Comp #: 2192 Bridge - Replace/Rebuild

Comments: Bridge structures determined to be in fair condition typically exhibit more moderate signs of exposure and wear to structural elements. Structure should be mostly level and stable, but at this stage, more exposed components may begin to wear at an accelerated pace. There is no expectation for a full replacement at this point. Still generally sturdy, but likely to require more frequent repairs and maintenance. Assuming normal wear and tear and good preventive maintenance, complete replacement or reconstruction may be required at longer intervals, including some or all components of structural framework, pilings, etc. If present, reconstruction may also need to include replacement of electrical infrastructure or other features. In our experience, all such projects are unique, and we strongly recommend consulting with engineers or experienced contractors to properly determine existing conditions and required scope of work. Our inspection is visual only and does not incorporate any specific testing or structural evaluation. At this time, costs related to this component are expected to be included in the Association's Operating budget or otherwise funded without the need for Reserve funds. No recommendation for Reserve funding at this time. However, any repair and maintenance or other related expenditures should be tracked, and this component should be re-evaluated during future Reserve Study updates based on most recent information and data available at that time. If deemed appropriate for Reserve funding, component can be included in the funding plan at that time.
